THE TOWN OF YADKINVILLE ADA TRANSITION PLAN

March 2021

WithersRavenel

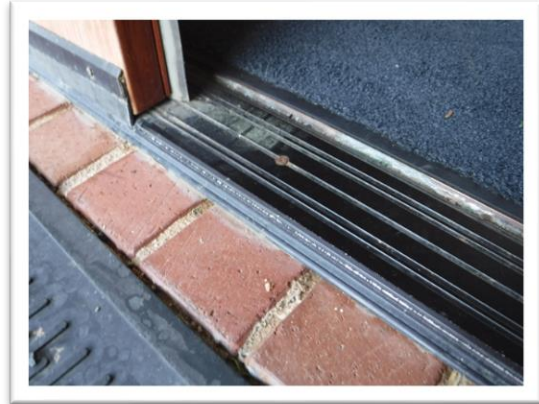
Figure 1: Entrance 1 (Approx. 0.48", 67% Slope)

- M/F Bathroom Entrances failed door pull.
- Main entrance interior and M/F Bathroom Entrances are not operable with a single hand without grasping.
- Entrances 1, 2, & 3 all had Thresholds that contained beveling greater than 1:2 (50% slope). See Figures 1-3.
- Entrance 3 Inner Threshold [not pictured] (Approx. 0.48", 70% Slope)
- Stall of both the Male and Female Handicap water closets do not contain Door Pulls on both sides of the Stall Door, and Locking Mechanisms proved difficult to operate with one hand without pinching or twisting of the wrist. See Figures 4 & 5.

Table 1: Town Hall Barriers	
Checklist Item	Failure Description
1.43	Main entrance exterior threshold beveling too steep.
1.43	Entrance #2 threshold beveling too steep.

Table 6: Town Hall Barrier Removal		
Checklist Item	Failure Description	Recommended Removal
1.43	Main entrance exterior threshold beveling too steep.	Remove/replace threshold beveling.

FY 2022 - 2023				
Town Hall				
1.43	\$	Maintenance Fund		Replace main entrance threshold beveling to be more flush with entrance.
1.43	\$	Maintenance Fund		Replace entrance #2 threshold beveling to be more flush with entrance.

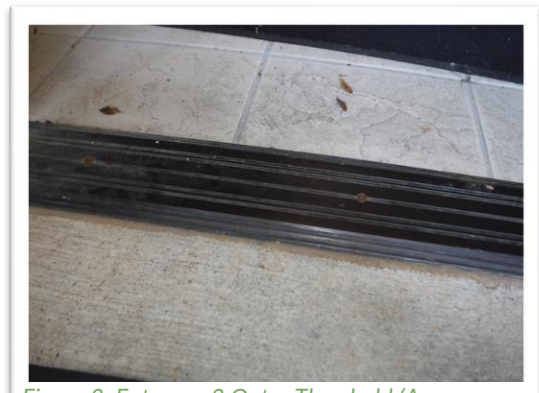
Figure 3: Entrance 3 Outer Threshold (Approx. 0.48", 85.3% Slope)

1.43	Entrance #3 exterior threshold beveling too steep.
1.43	Entrance #3 interior threshold beveling too steep.
1.44	Main entrance interior handle is not operable with single had.

1.43	Entrance #2 threshold beveling too steep.	Remove/replace threshold beveling.
1.43	Entrance #3 exterior threshold beveling too steep.	Remove/replace threshold beveling.

1.43	Entrance #3 interior threshold beveling too steep.	Remove/replace threshold beveling.
1.44	Main entrance interior handle is not operable with single had.	Replace handle fixture.

1.43	\$	Maintenance Fund		Replace entrance #3 exterior threshold beveling to be more flush with entrance.
1.43	\$	Maintenance Fund		Replace entrance #3 interior threshold beveling to be more flush with entrance.

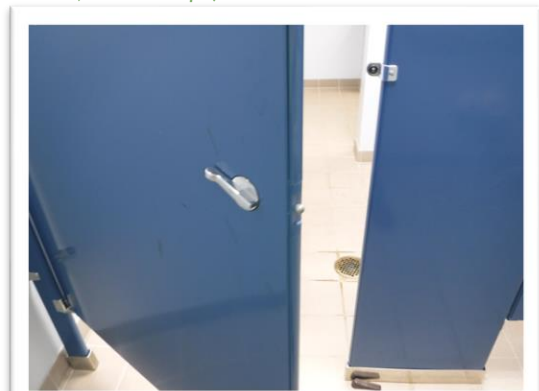
Figure 5: Male Stall Lock Mechanism

3.43	Female handicap stall door is not self-closing.
3.45	Male handicap stall door lock is not operable with one hand without pinching or twisting of wrist.

3.43	Male handicap stall door is not self-closing.	Add closer.
3.43	Female handicap stall door is not self-closing.	Add closer.
3.45	Male handicap stall door lock is not operable with one hand without pinching or twisting of wrist.	Replace lock.

FY 2025 - 2026				
Town Hall				
3.43 - 3.45	\$\$	ADA Remedial Funds		Add closer to male bathroom handicap stall and replace locking mechanism that is usable with one hand without pinching or twisting wrist. Replacement stall door may be required.

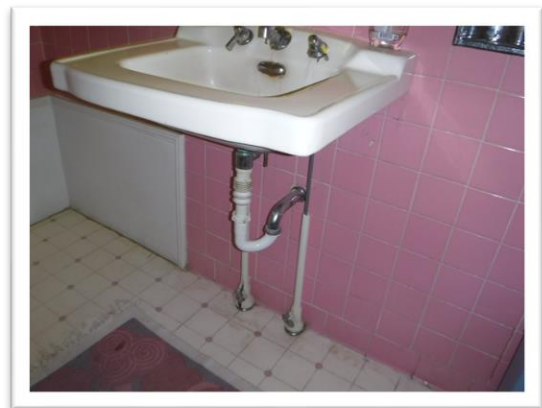
Figure 11: Bathroom Sink Obstructions

- The mirror over the countertop sits 11" higher than the maximum height required.
- Pipes under the sink are currently exposed and run into the floor of the bathroom obstructing toe clearance and exposure requirements. See Figure 11.

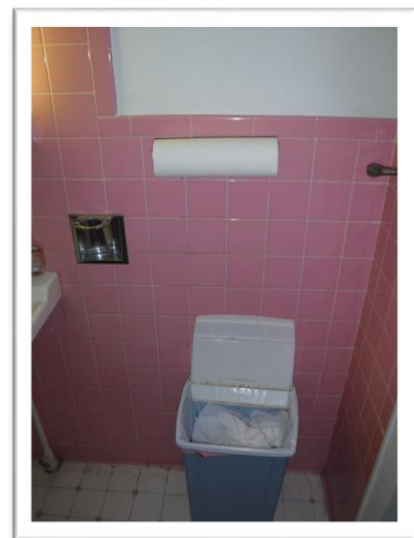
Figure 12: Bathroom Towel Dispenser

- Towel dispenser was placed over an obstruction (trash can) and installed at 50.25" above the ground. See Figure 12.
- Clearance width provided around the toilet was 33.75" wide, with the sink obstructing further clearance. This is below the required 60" minimum width.

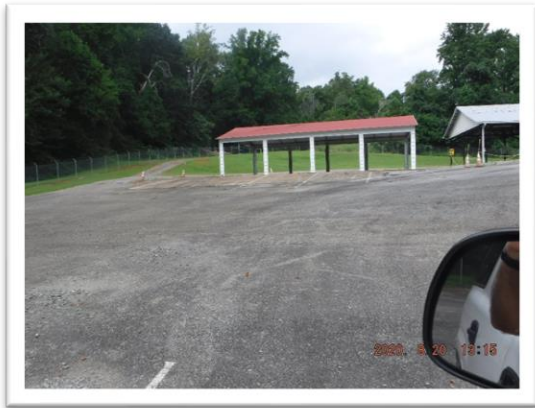
Figure 13: Farmer's Market Surface and Slope

- Topographic and surface conditions of the Farmer's Market Lot make access to facilities difficult. See Figure 13.
- Farmer's Market bathroom door threshold exceeds the 3/4th inch beveling threshold. See Figure 14.
- Community Park male bathroom exterior handle is mounted well above accessible threshold. See Figure 15.
- Community Park female bathroom exterior handle is mounted well above accessible threshold.
- Community Park male and female bathroom doors failed both door pull and closer time thresholds.
- Community Park male and female stall handle hardware requires twisting of the wrist or pinching to operate. See Figures 16 & 17.
- The force required to operate the Farmer's Market bathroom faucet exceeds 5 lbs. of force to use.
- The force to use the Farmer's Market toilet flush exceeds 5 lbs. of force to use.
- Community Park female bathroom stall is not self-closing.

Note #2: The slope and surface materials of the Farmer's Market parking lot prevent accessibility to both the public bathroom and market stalls on the site. As it currently exists, the site is not considered to be accessible for peoples with mobility disabilities. Therefore, it is recommended that the Town develop an accessibility plan for the site that establishes accessible walkway materials with smooth grade changes between the bathroom, stalls, and accessible parking spaces.

2.2 & 3.4	\$\$\$	ADA Transition Plan Special Funding		Conduct Farmer's Market Redevelopment Plan per Comment #2.
3.5	\$	Maintenance Fund		Replace Farmer's Market bathroom sign with one that includes braille.

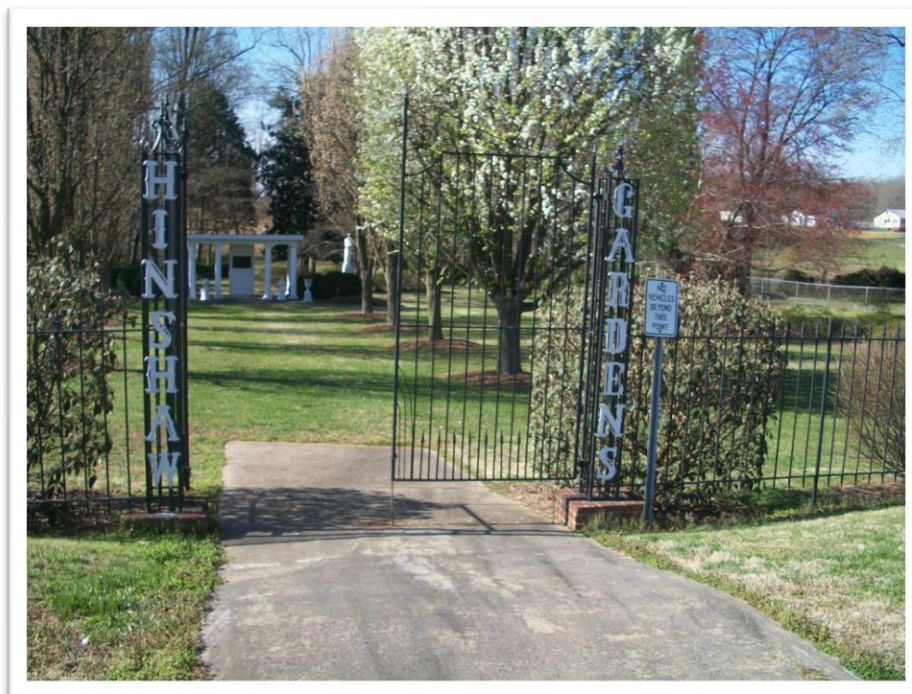
Figure 18: Hinshaw Gardens

Hinshaw Gardens (see Figure 18) is developed and maintained to provide a more natural condition and appearance. As such, the park maintains a natural topography and is maintained without footpaths. It offers guests a place to get away from paved facilities, and to lose themselves in the park's intended atmosphere.

As part of 36 CFR Part 1191 RIN 3014-AA22: Architectural Barriers Act Accessibility Guidelines; Outdoor Development Areas, it is asserted that Hinshaw Gardens would be exempt from accessibility under the conditions that Compliance would fundamentally alter the function or purpose of the facility or setting. It is argued that paving or construction of paved paths would impact the physical aesthetic, and therefore importance of the park's function.

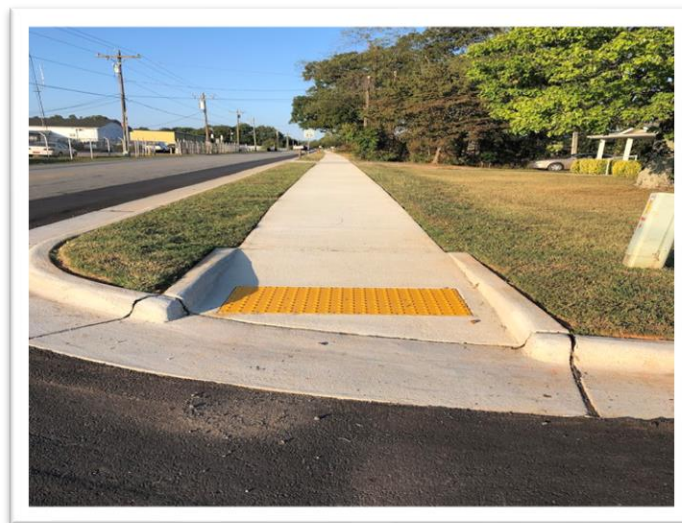
Figure 19: Satisfactory Example

Figure 19 provides an example of a satisfactory ramp, crossing and sidewalk. Notice the detectable warning domes, even lips, wide landing, and flat sidewalk. There are no obstructions in the vicinity of this image and someone using a wheelchair or cane could use this facility.

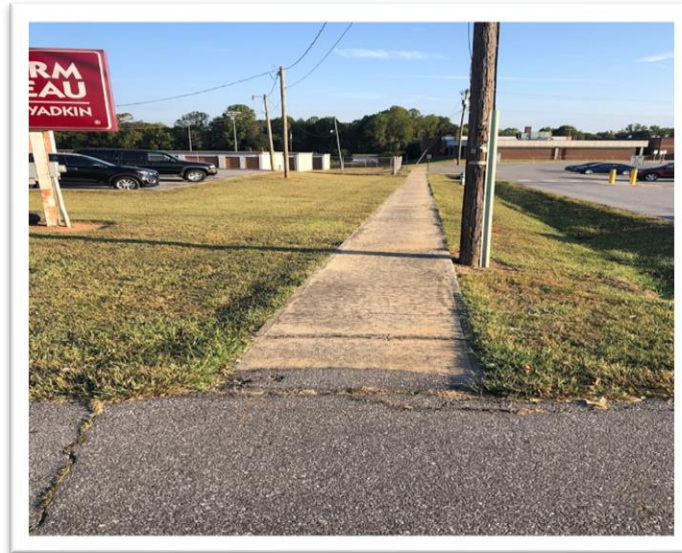
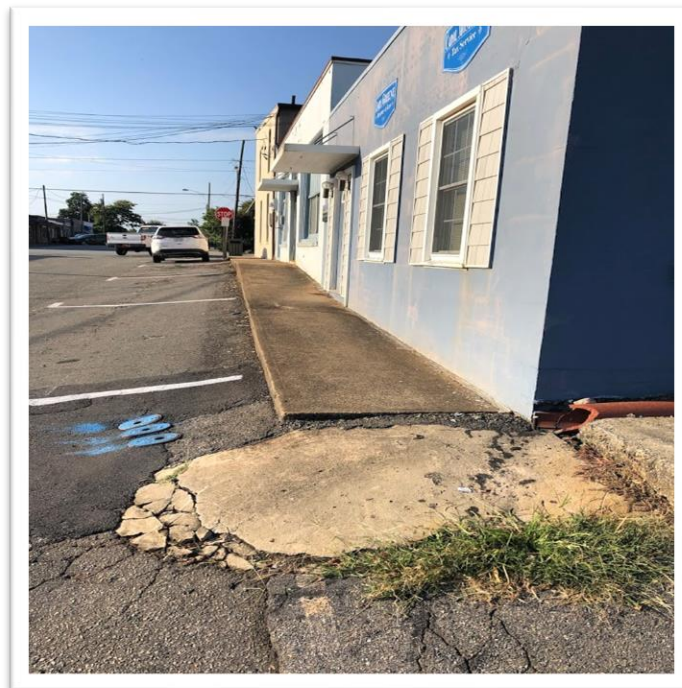
Figure 20: Barrier Example

Figures 20 and 21 demonstrate both a lack of detectable warning domes. Figure 21 also demonstrates uneven lips at the top and bottom of the ramp. It is apparent that someone using a wheelchair may have difficulty getting to the sidewalk along these businesses.

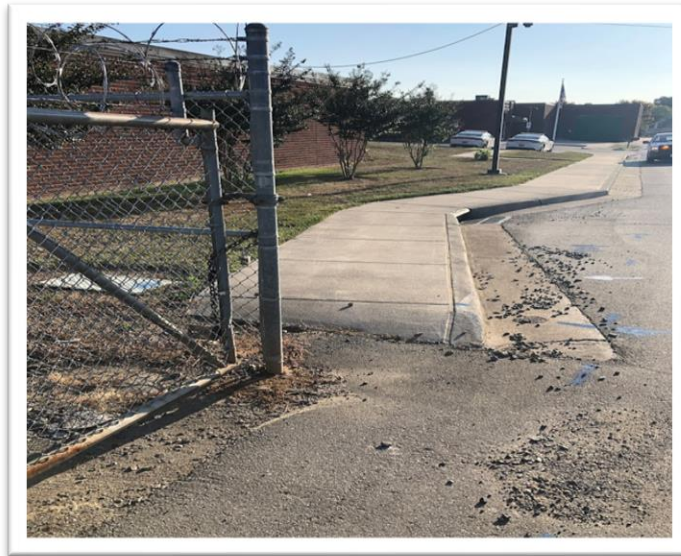
Figure22: Barrier Example

Figure 22 demonstrates very healthy-looking sidewalk, but unfortunately there is an obstructed curb ramp. It is difficult to tell if a person using a wheelchair would be able to find the space to ascend this ramp, and the presence of the pole pushes that person further into the street.

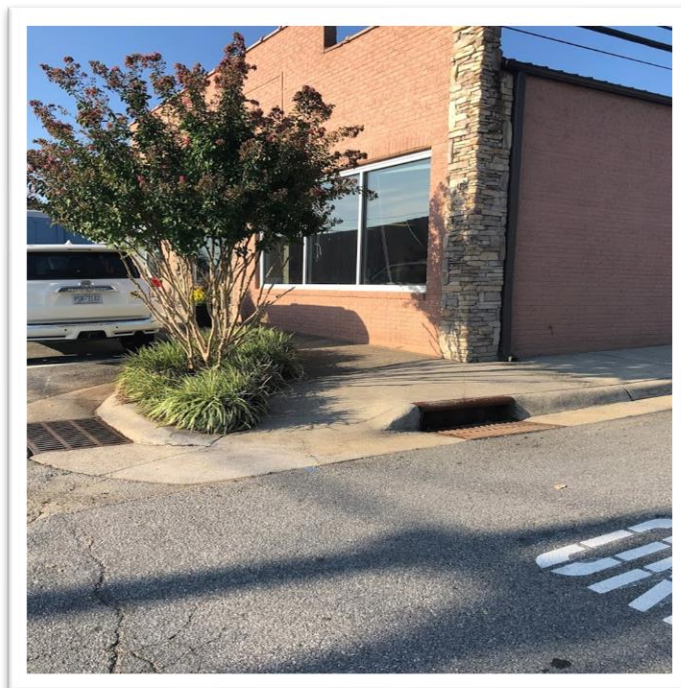
Figure 23: Barrier Example

Figure 23 depicts a ramp that doesn't guide the user in the correct direction when they are going down it. The ramp takes the user directly into the parallel street. Additionally, the ramp's running slope most certainly exceeds the maximum requirement of 1:12.

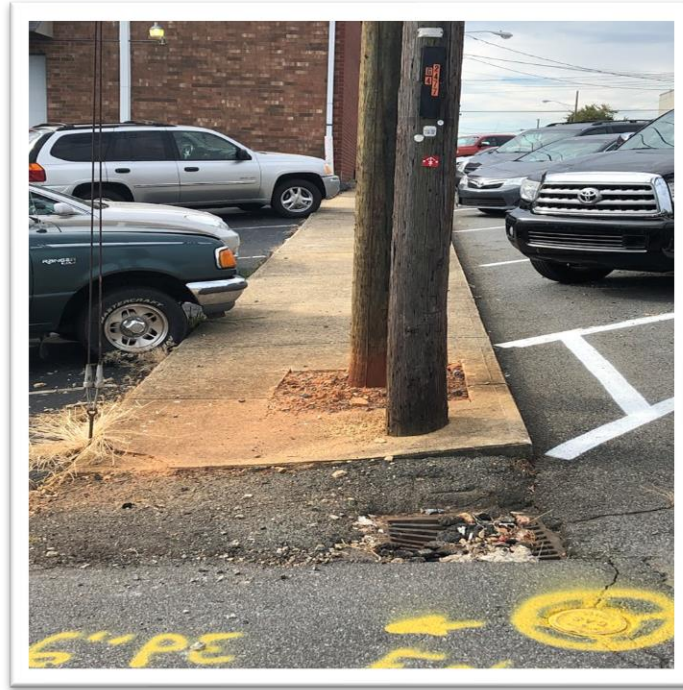
Figure 24: Barrier Example 5

Figure 24 demonstrates several barriers to access including physical poles obstructing the sidewalk, the lack of any ramp and uneven lips where the asphalt meets the concrete, a sidewalk crossing slope that appears too steep and a physical grate blocking the sidewalk. There is also no level 4-foot by 4-foot landing present.

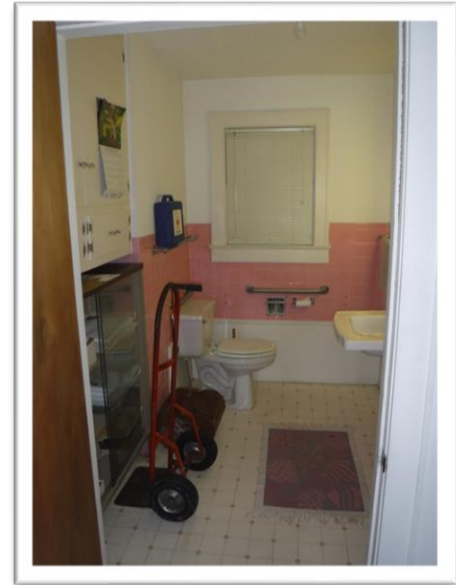
Figure 25: Chamber of Commerce Bathroom

Note 1: The Chamber of Commerce building bathroom is currently very antiquated and will require an overhaul to fix many of the above items. Such a project would most likely require the consulting the services of a contractor to conduct the necessary upgrades listed above. This may involve expanding the bathroom itself in order to achieve the required spacing needed for a wheelchair turnaround and sink and light switch approaches. An expert will be able to determine if such expansion is needed, or if removal of the existing storage space in the facility will achieve the minimum spacing goals. Regardless of those items, various fixture adjustments, door adjustments, and obstruction removal should be grouped together into a single line item project for barrier removal.
